Update to 2023-CC-SRC-039

TGA Reference #:	RC-2024-RN-00257-1
Product / Device Name / Model #	BiPAP A30, BiPAP A40, BiPAP A40 Pro
ARTG Ref #	133794, 200289, 329407, 329408
Short Problem Description	Interruptions and/or loss of therapy due to a Ventilation Inoperative Alarm

This is an update to RC-2024-RN-00257-1 (2023-CC-SRC-039-C) sent in November 2024.

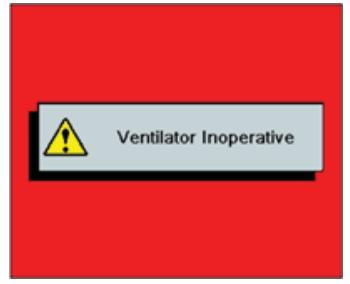
If a Ventilator Inoperative alarm occurs, the display screen turns red and the Ventilator Inoperative message appears on-screen, as shown below.

To perform the hard reboot, please follow the instructions below:

1. Disconnect from the device.

- 2. Power off the therapy device.
 - Press the Start/Stop button ((b)).
 - If the ventilator display is operational, the "Power Off" confirmation screen will appear, as shown below.
